TEST REPORT FOR
JET PROPULSION LABORATORY
TOROIDAL TRANSFORMERS
PROCEDURE 902.66-01

VARO, INCORPORATED
ENVIRONMENTAL LABORATORY

FINAL REPORT

December 24, 1965

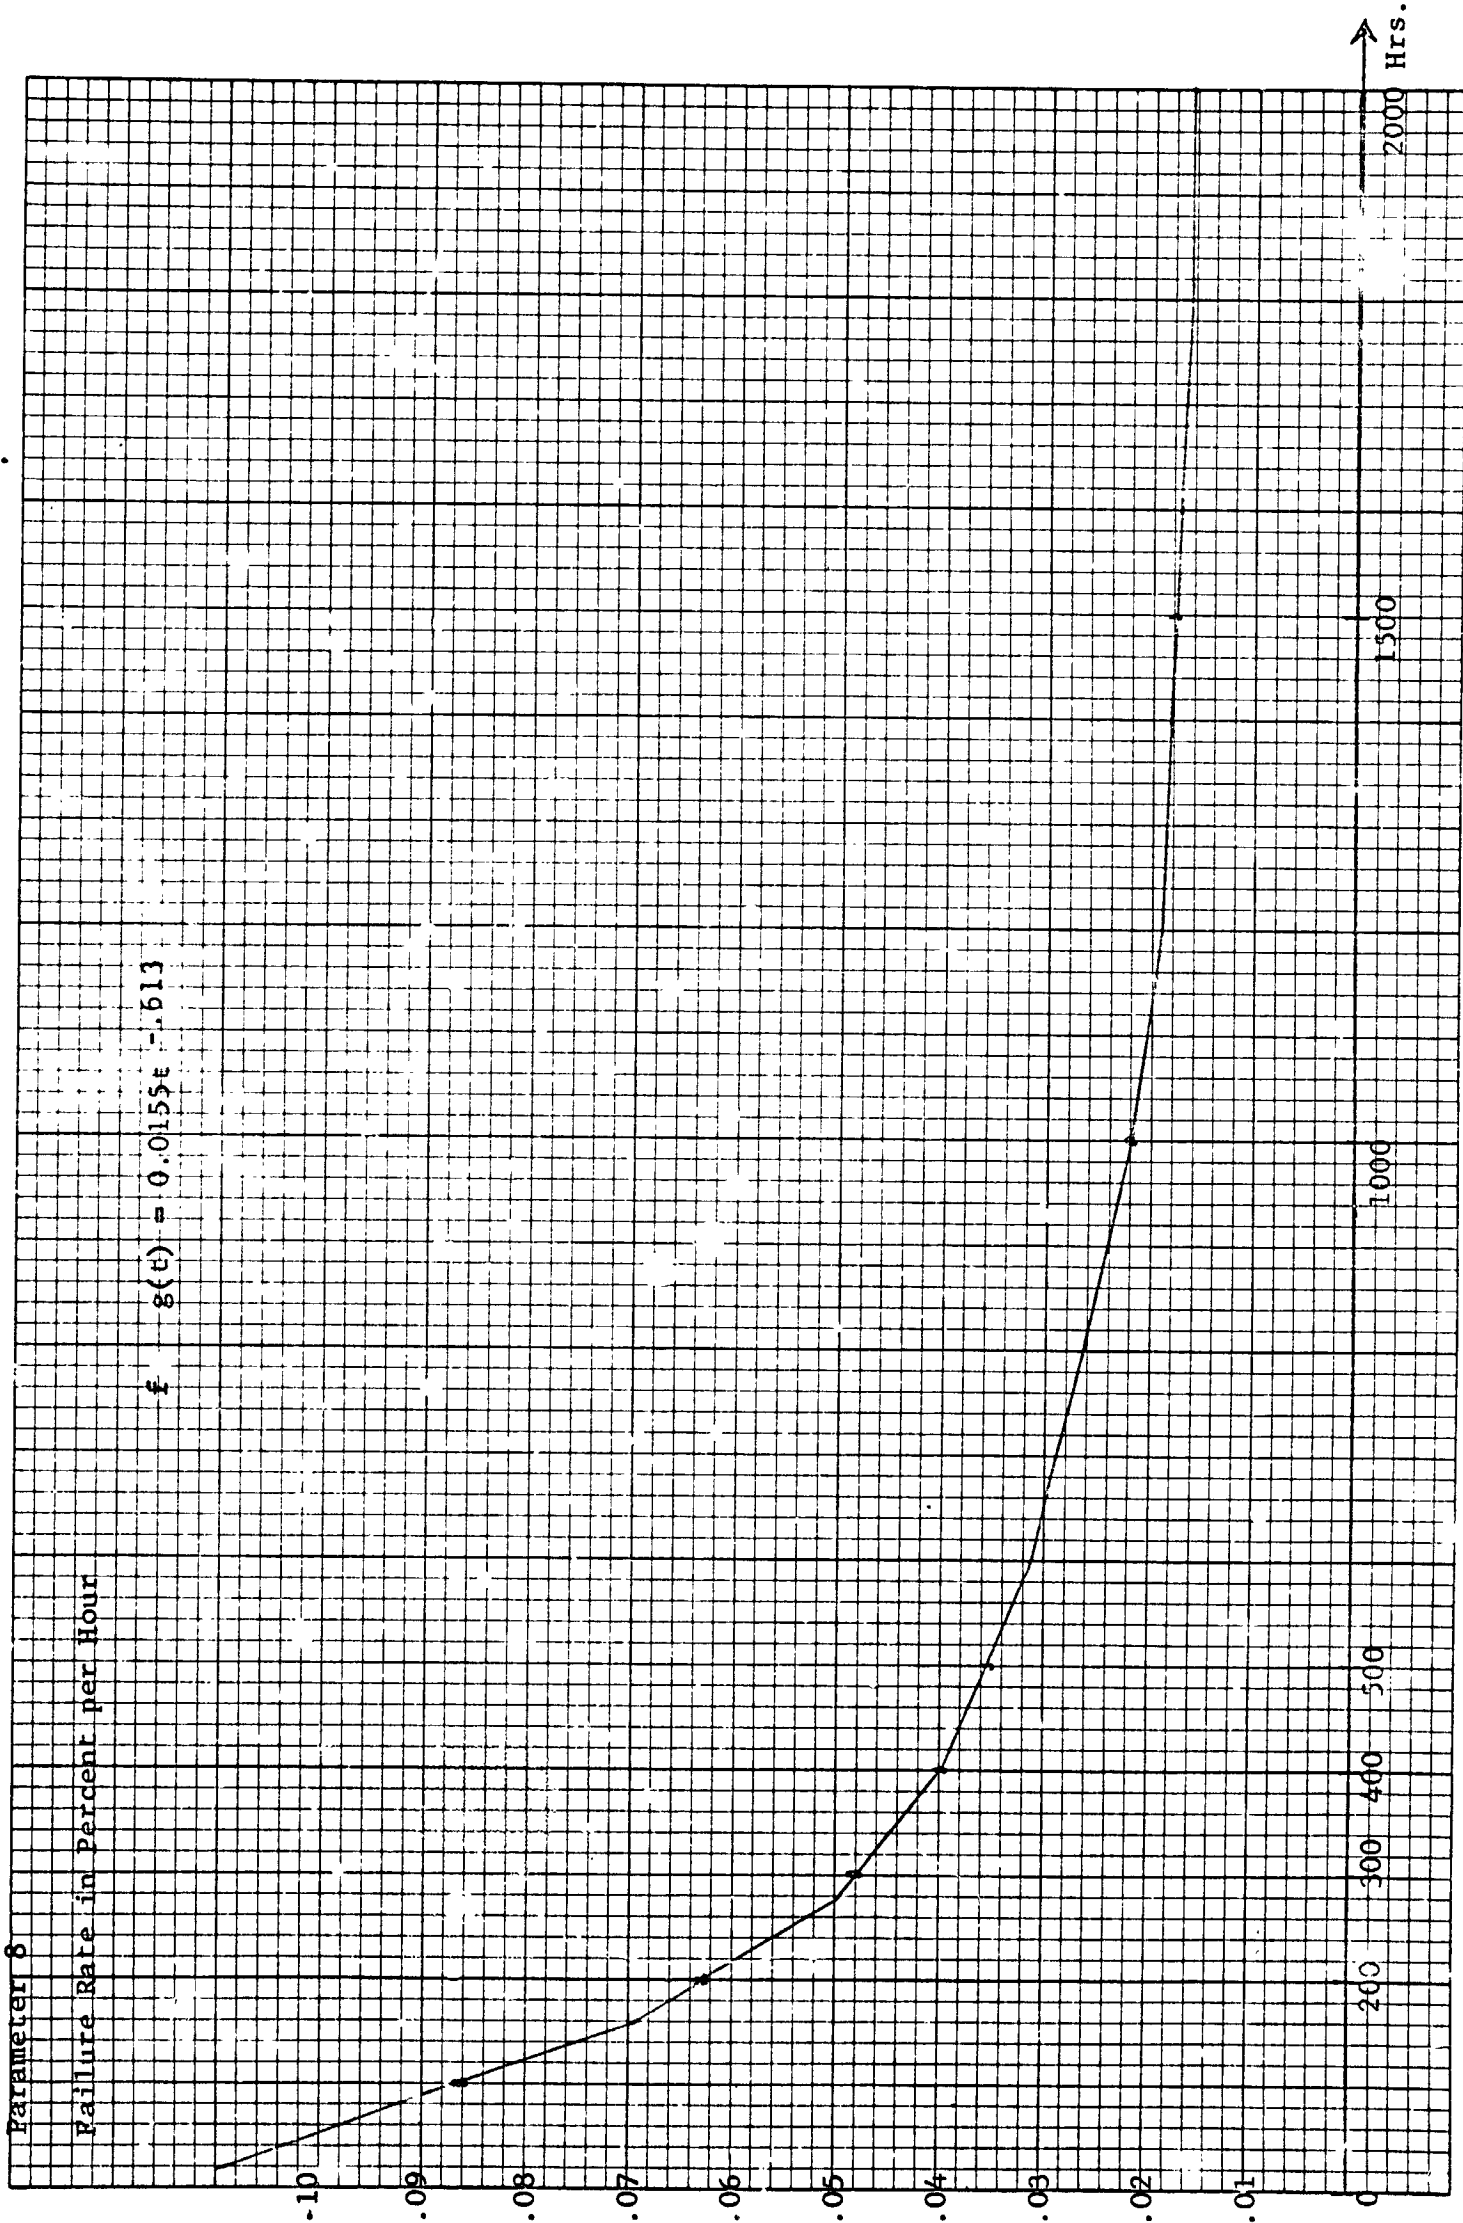
Part D3172671
Vendor Hadley

$$f \quad g(t) = 0.0155t^{-.613}$$
